**DECATUR
INDUSTRIAL
ELECTRIC**

GEARBOX CASE STUDY:

Coal Generating Facility Emergency Repair FALK Gearbox - Application Coal Crusher 1500HP

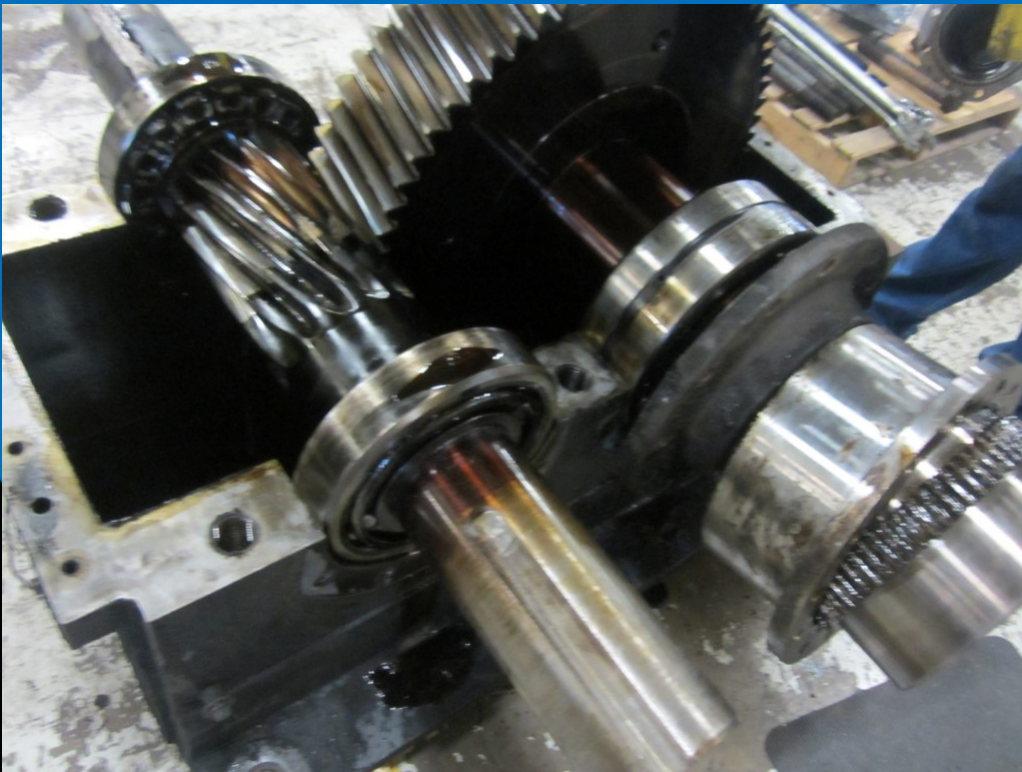
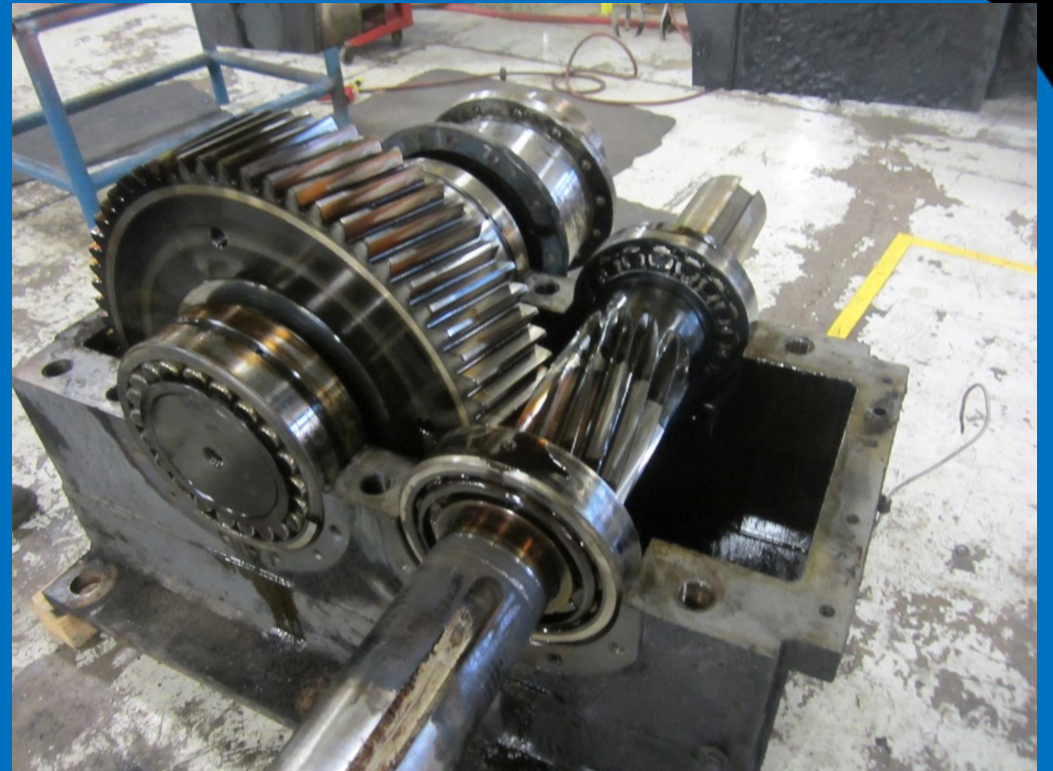
Heavy Oil Oxidation from Heat

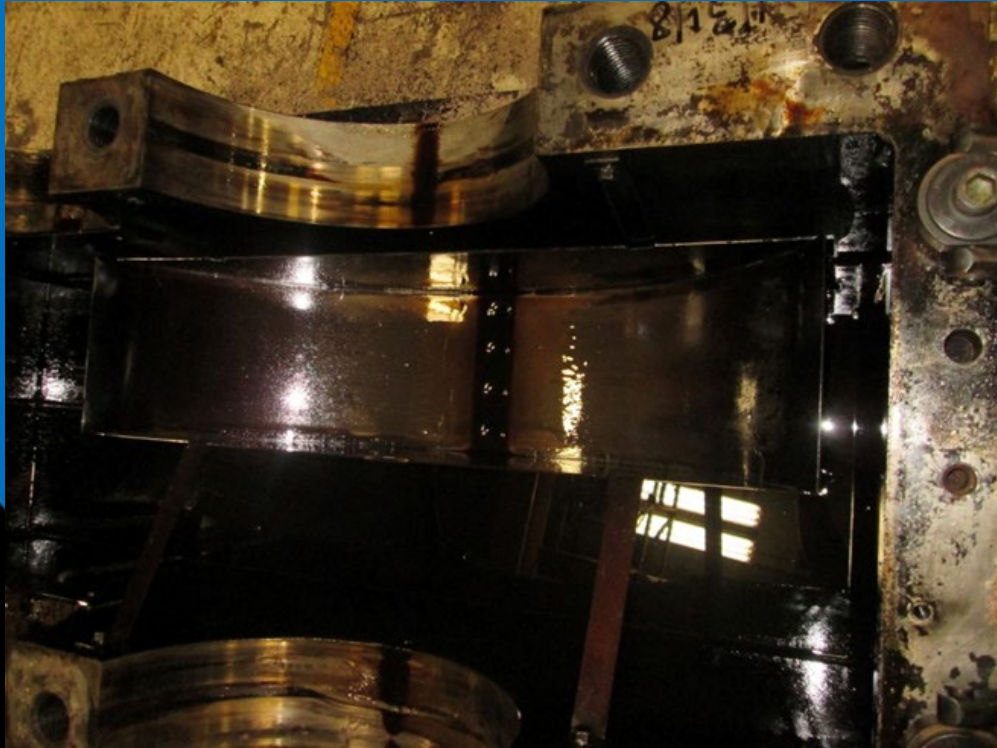
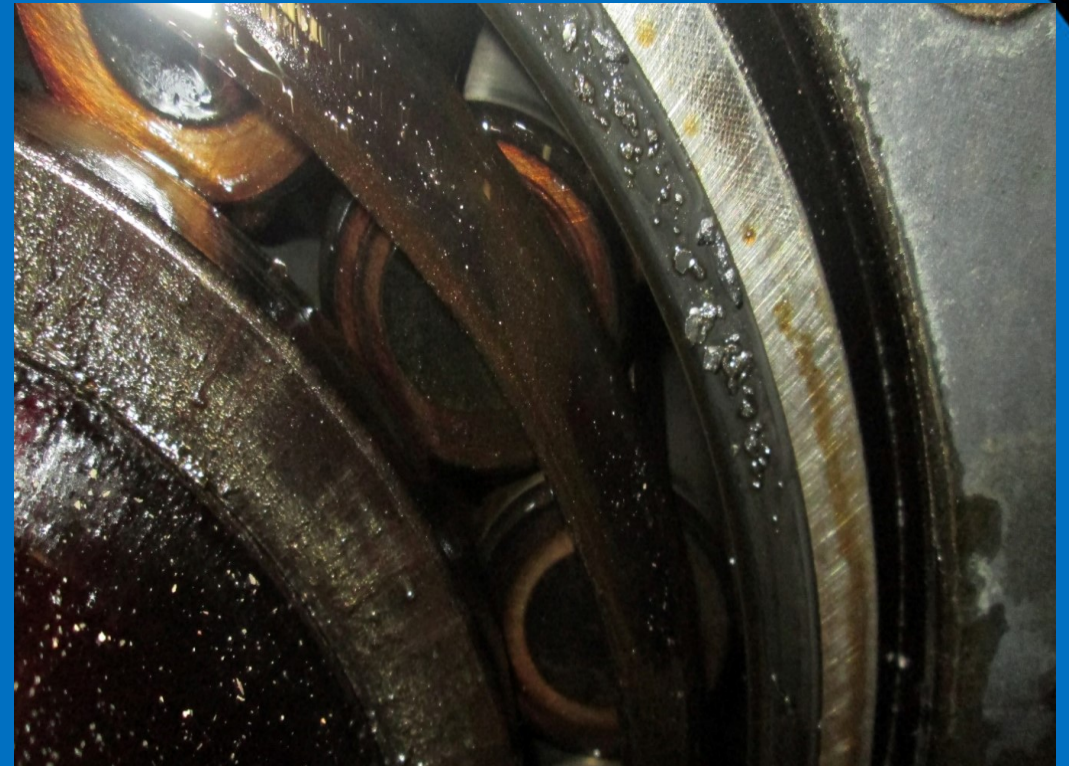
Fractured bearing discovered during autopsy.

Bearing overloaded and failure due to coupling misalignment.

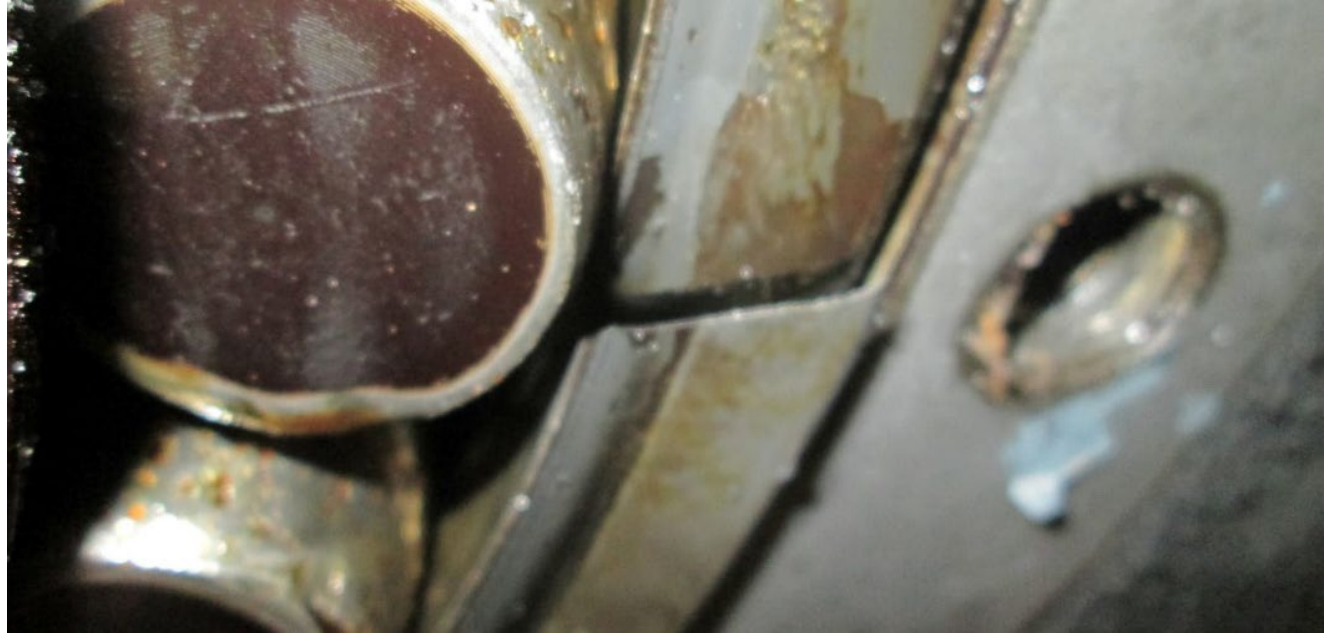
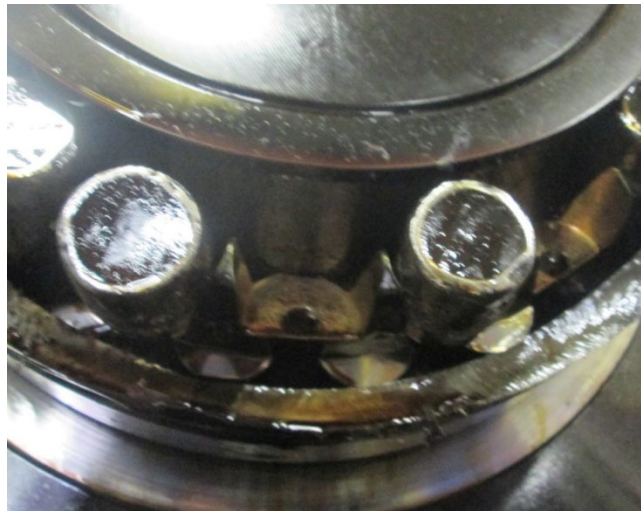
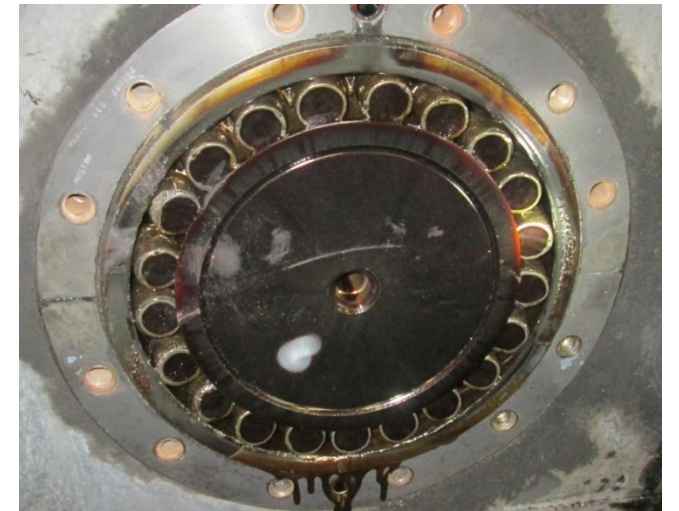
Examination
of output
shaft found
repetitive
surface marks

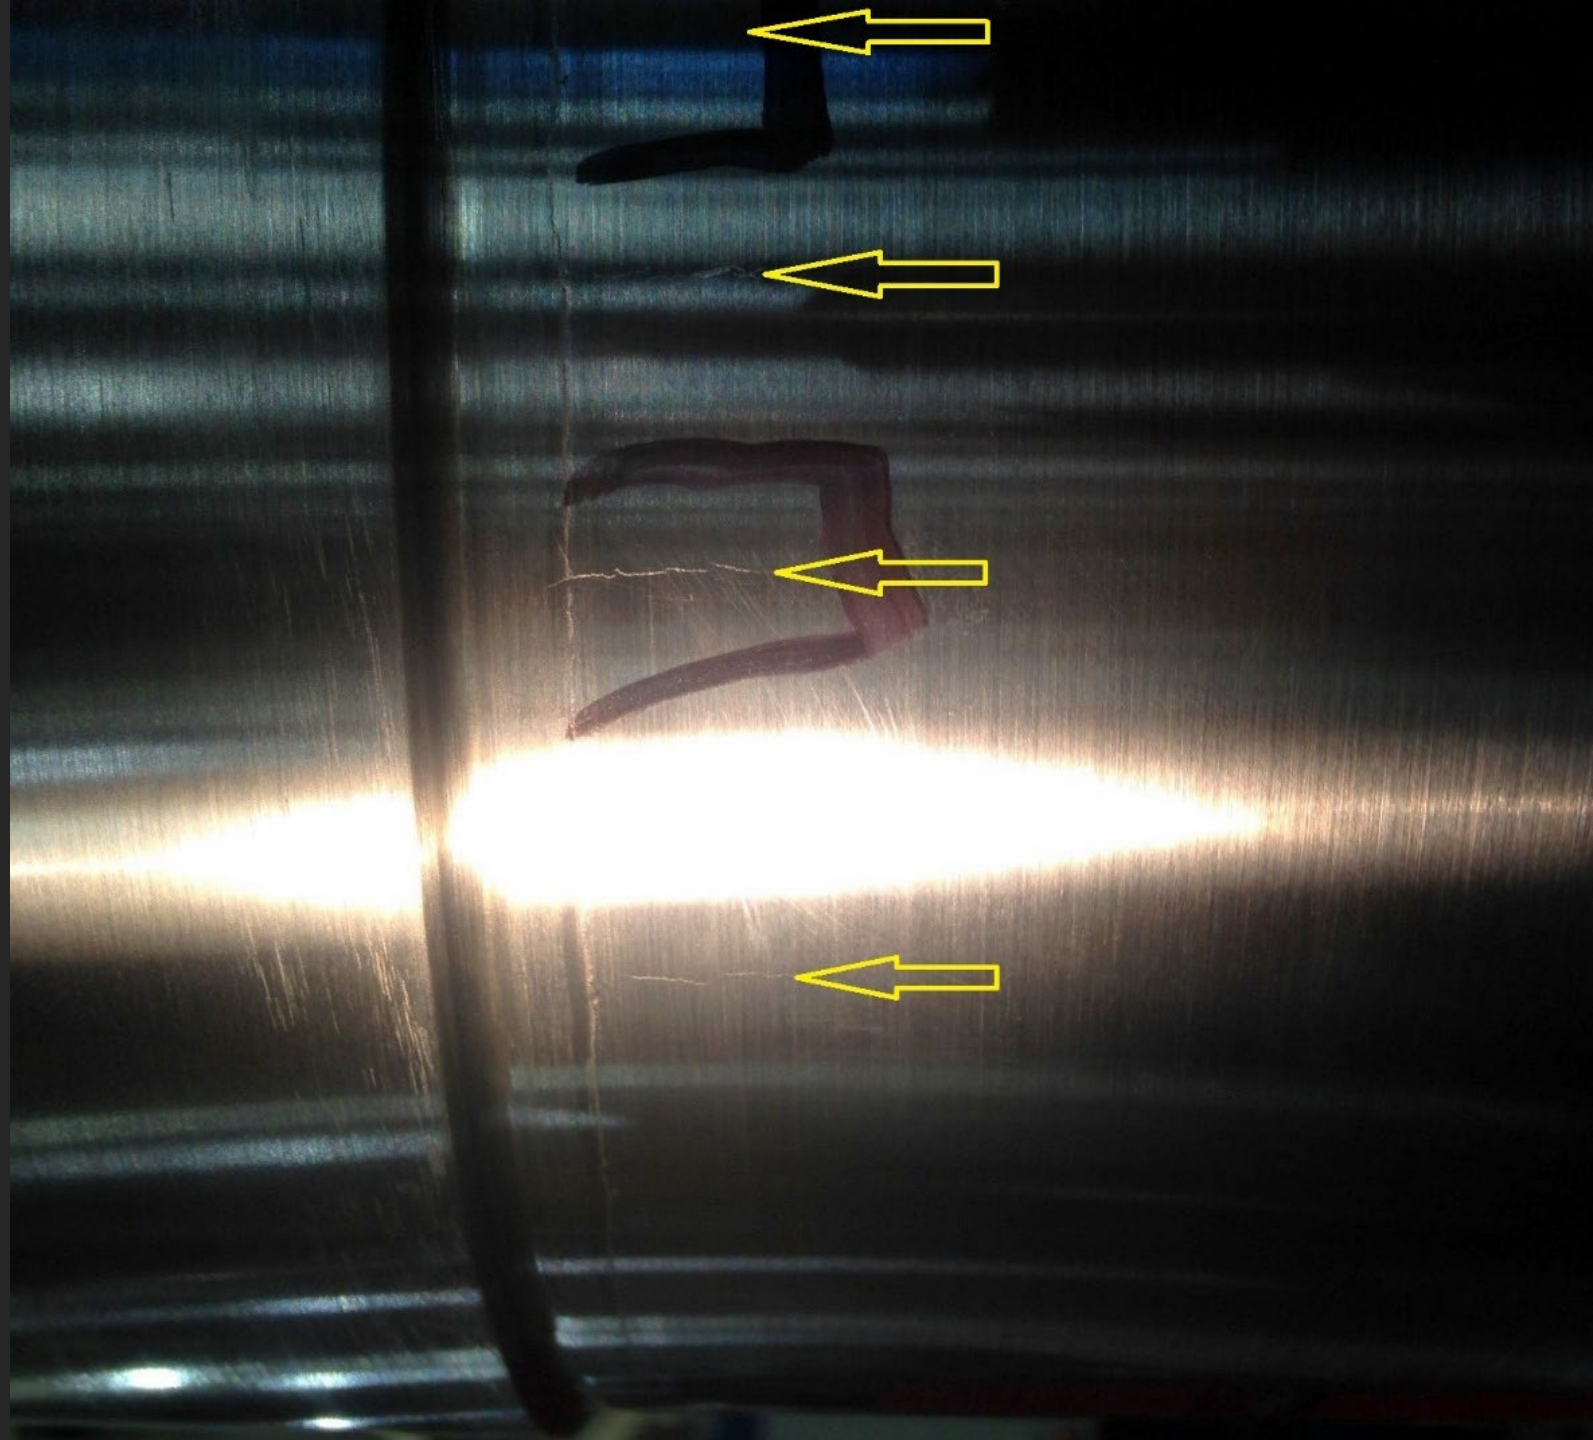
Further investigation found
an output shaft
turn in lathe .100"
smaller for deeper structure
evaluation and
additional marks appeared

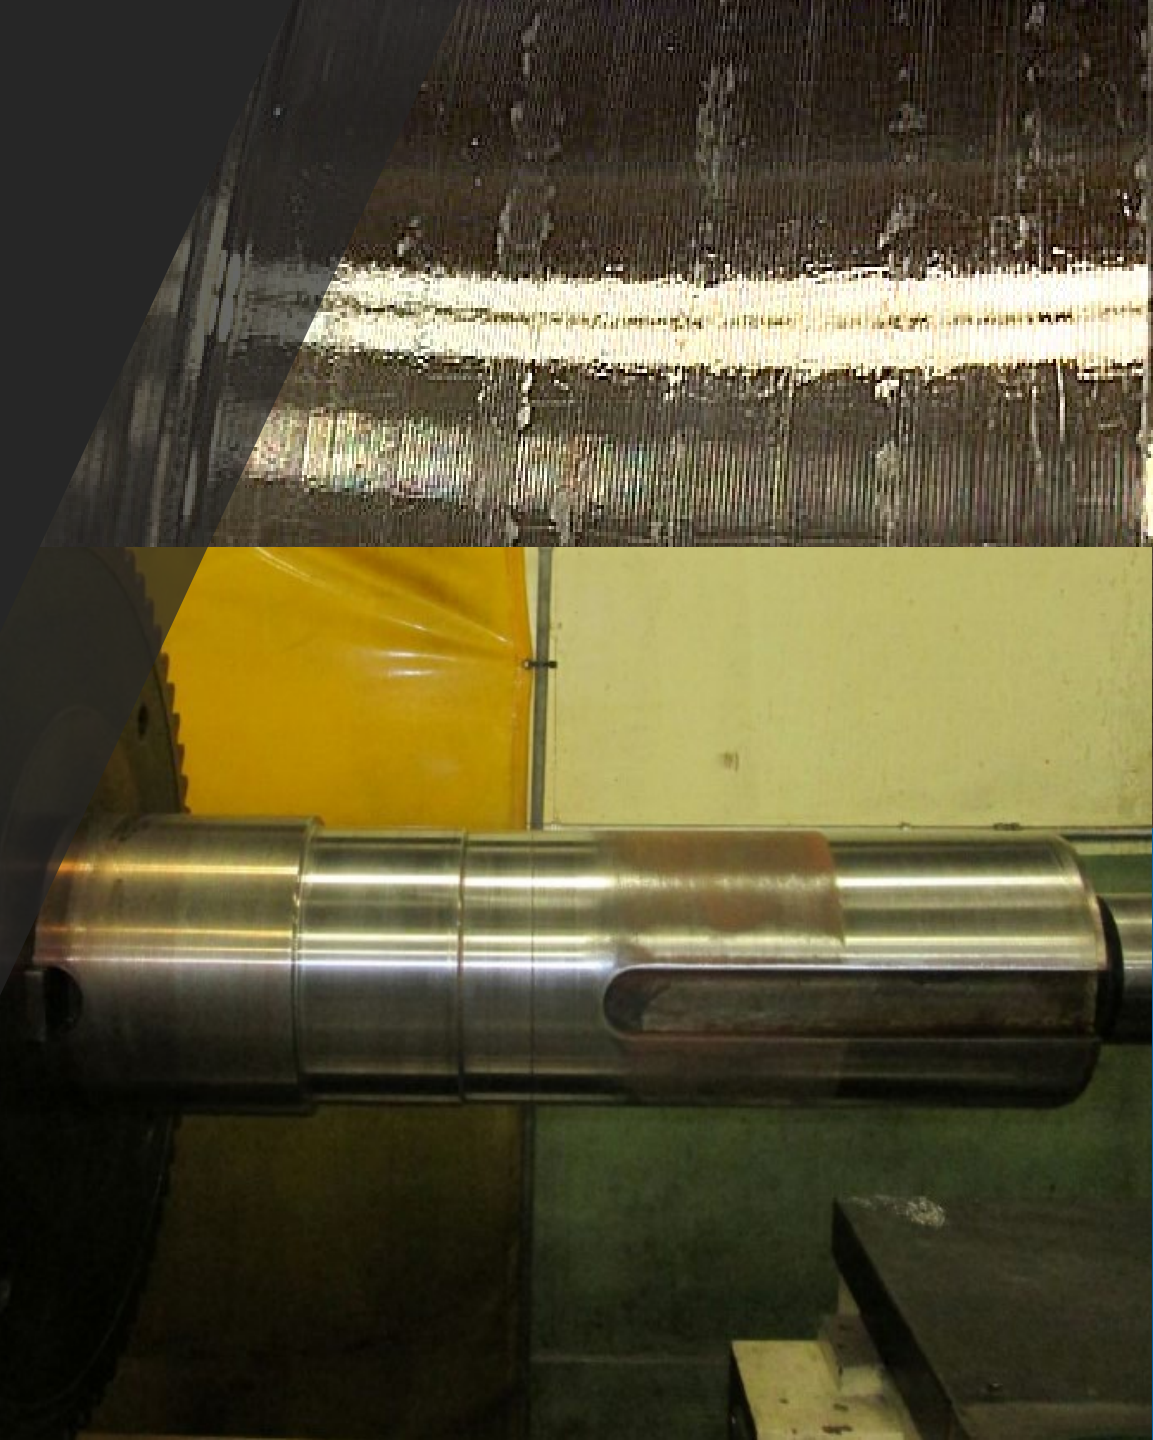
Dye penetrant check shows multiple parallel cracks due to fatigue

Subsequent shaft damage due to shock load fatigue.
