**DECATUR
INDUSTRIAL
ELECTRIC**

GEARBOX CASE STUDY:

Coal Generating Facility Emergency Repair FALK Gearbox - Application Coal Crusher 1500HP

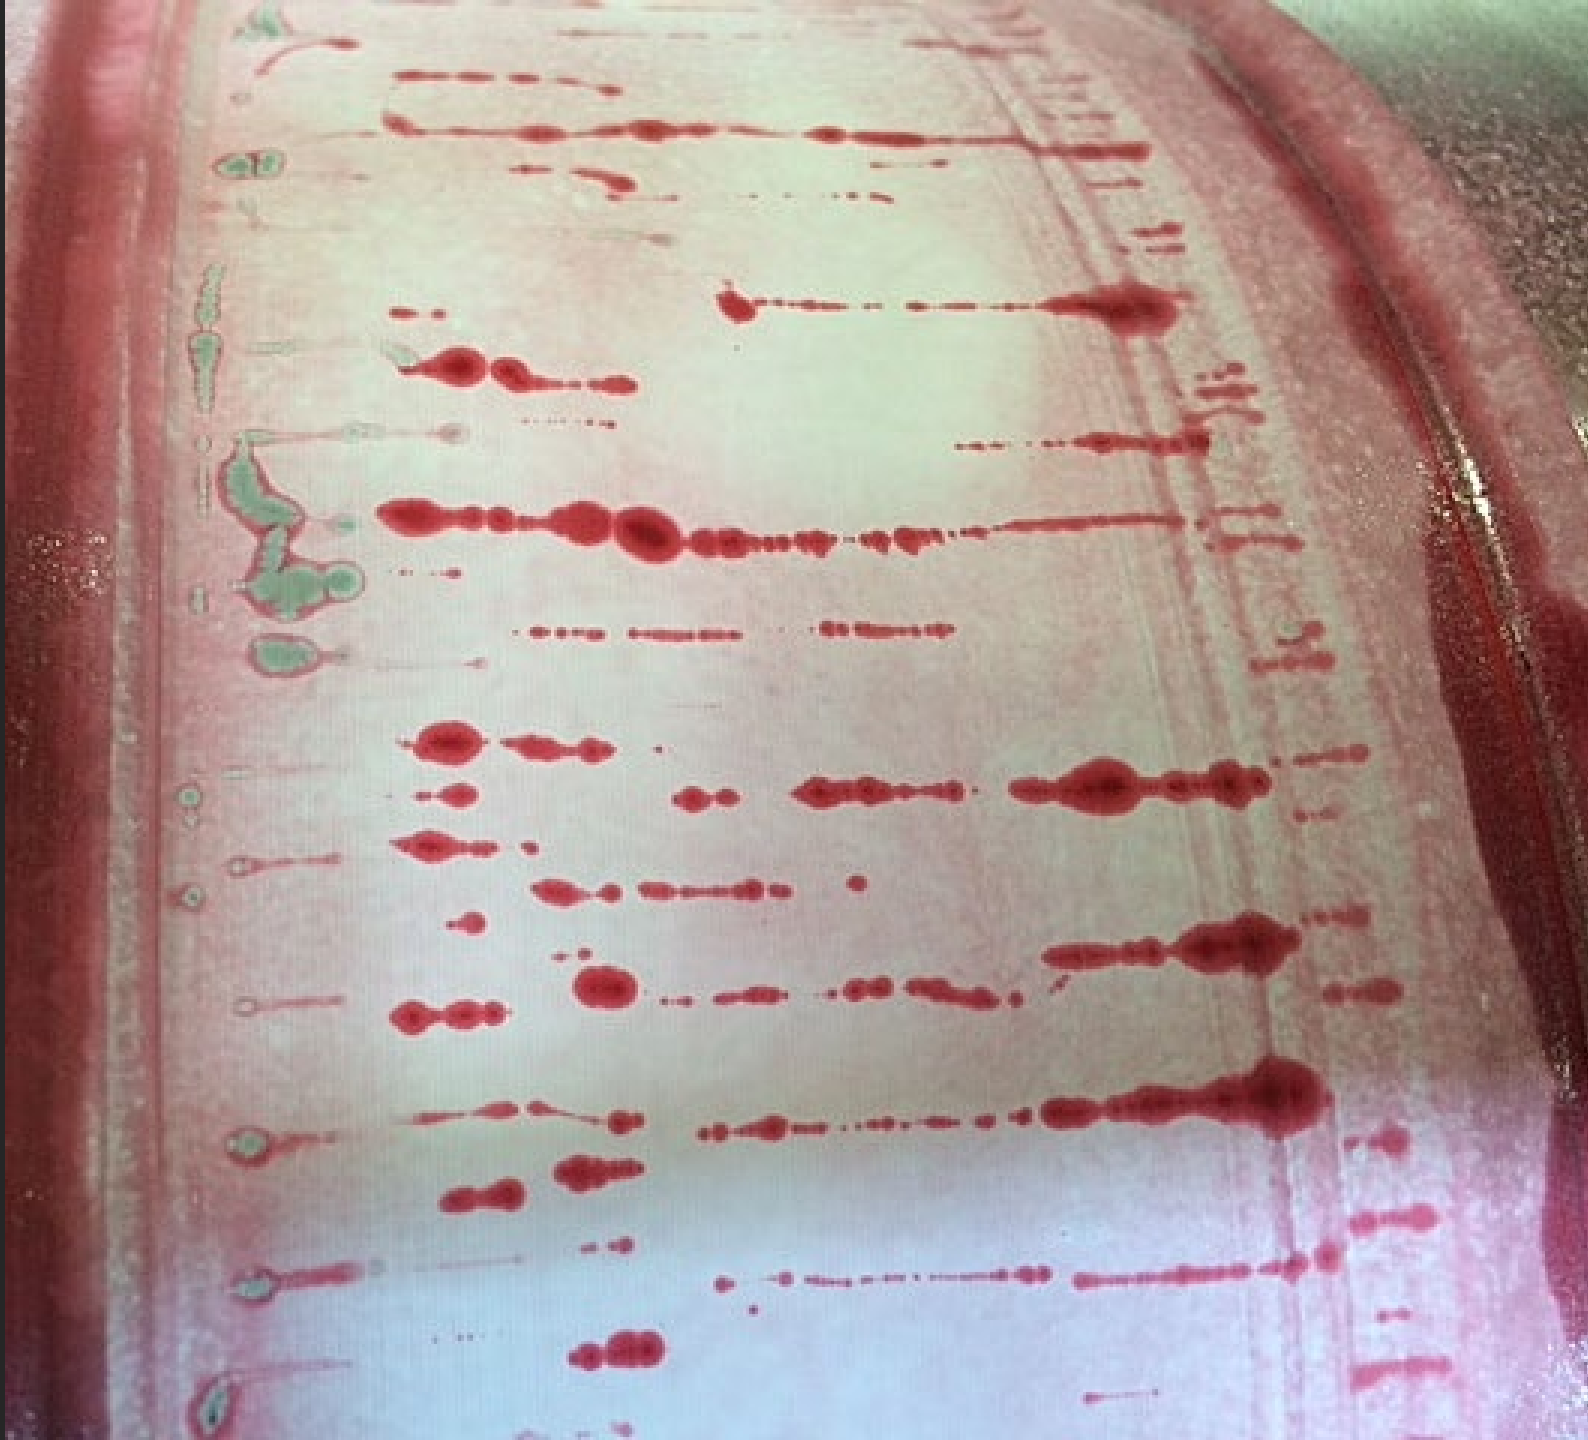
Dye penetrant check shows multiple parallel cracks due to fatigue

Bearing overloaded and failure due to coupling misalignment.

Subsequent shaft damage due to shock load fatigue.
